Rib Fixation Plates

System Overview

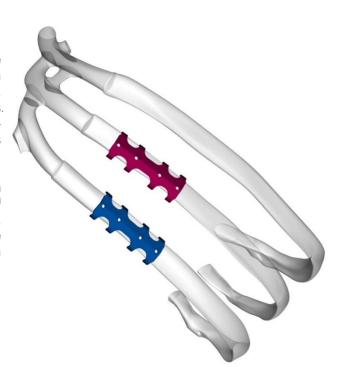
Surgery may be needed if the ribs are badly fractured. Broken ribs may be held together with plates and screws. The $AUXO^{TM}$ Rib Fixation Plate is suitable for patients with floating chest, flail chest or pneumohemothorax. Also, it can be applied to the internal fixation of single and multiple rib dislocations in thoractomy.

- The rib fixation plate system is flexible and contains no iron.
- It is compatible with the tissue perfectly, and has no affection on the thoracic CT or MRI inspection.
- After the operation, the plates don't have to be removed.
